Beyond the Wires

A Sustainable Approach to Prestressed Concrete Cylinder Pipe Management

Nathan D. Faber, P.E.¹, Martin R. Coghill CEng MICE², and John J. Galleher, P.E.³

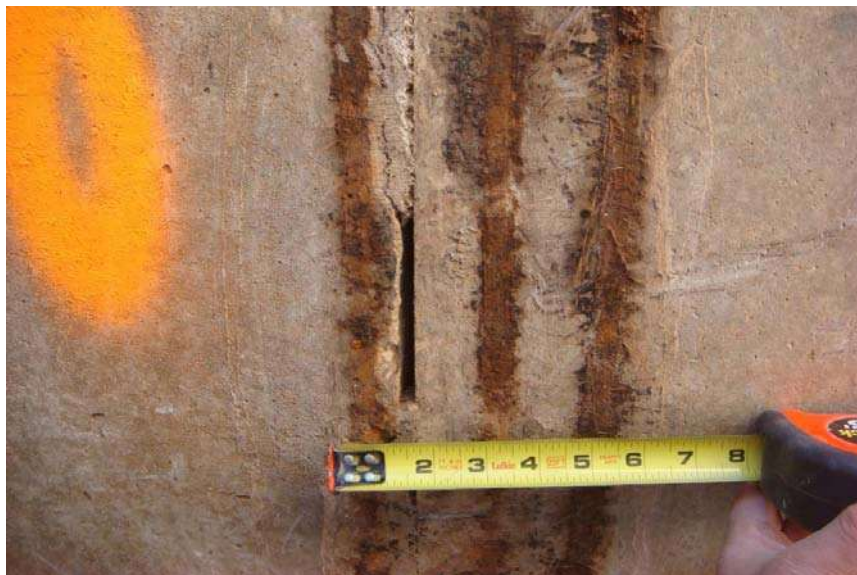
Field Joint Conditions. The condition of joints is important. The Water Authority has experienced 12 PCCP breaks. Six of these PCCP breaks were caused by factors other than wire breaks, including two caused by corrosion at the joint and two caused by cylinder corrosion. External excavations on Water Authority pipelines have shown several joints with insufficient and/or poorly applied external mortar (See Figure 1).

Figure 1 - Poor PCCP Joint Mortar

These defects allow moisture to penetrate to the joint ring and cause corrosion on the cylinder to joint ring weld and wires near the joint. This has led to PCCP breaks due to joint ring separation from the cylinder (Figure 2), cylinder corrosion and wire breaks near the joint as in Vidmar, et al. 2008.

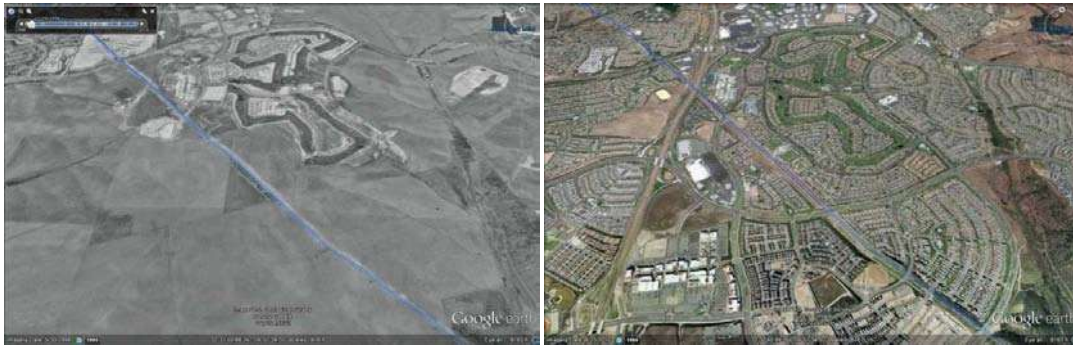
Location. The pipeline's physical location can affect the approach selected to rehabilitate the pipeline. For example, a pipeline may be in a rural setting with minimal potential for property damage in the immediate vicinity; however downstream drainage within an urban catchment may be insufficient to deal with the pipeline failure. This could result in flooding and subsequent property damage. Changing land use can also have an impact on rehabilitation selection. For example, an area alongside the Water Authority's pipeline has changed in the past 10 years from rural livestock grazing farmland, into densely populated communities and associated infrastructure (Figure 3).

Figure 3 – Changing Land Use Around Pipeline Alignment

This directly affects the assessment of potential for damage and increases the consequence of failure of the pipeline.

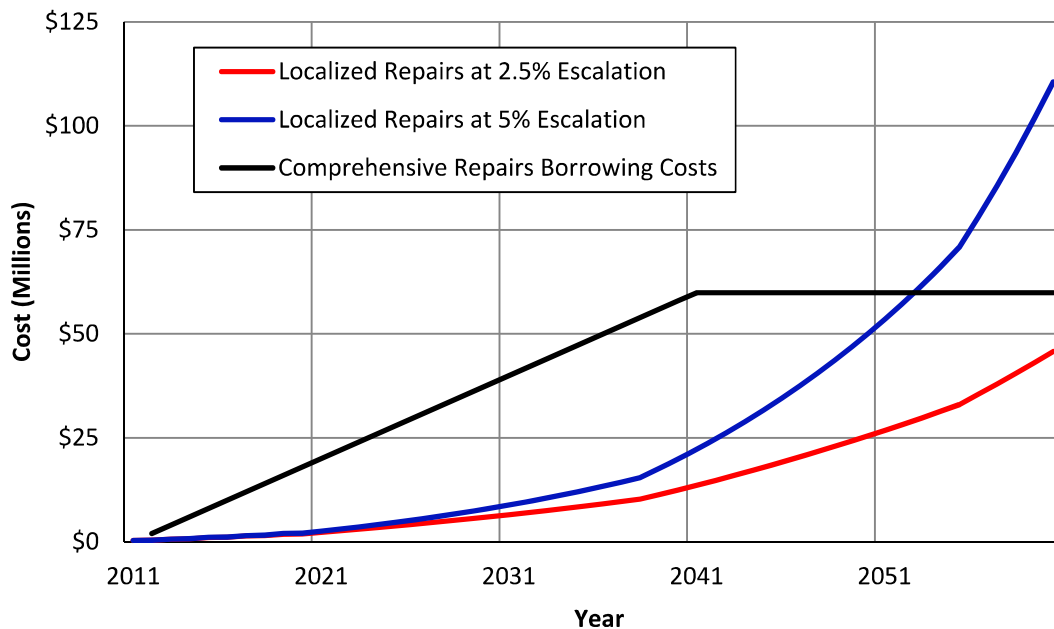
The second approach considered would be a comprehensive rehabilitation for the entire reach. The cost for this rehabilitation is estimated at \$29-million. Bond financing for this would result in a total cost of \$60 million at the end of a 30-year lending period. Table 7 and Figure 4 shows a cost comparison for these two approaches.

Figure 4 - Cost Comparison of As-Needed vs. Comprehensive Rehabilitation

The costs for the as-needed repair approach would be between \$45-million and \$110-million (assuming a range of annual price escalation and inflation combined between 2.5-percent and 5-percent). Acoustic monitoring would be required for the life of the pipeline for this approach. These additional maintenance costs have not been included in the analysis.

Sustainability. For the Pipeline A section, the comprehensive rehabilitation approach is more sustainable over 50-years in terms of cost and the reduction of risk is significantly greater. Future generations are left with an asset that has an extended serviceable life.
