Large Southern Water Utility

PREVENTING MAIN BREAKS WITH ADVANCED INSPECTION TECHNOLOGIES THAT IDENTIFY STRAY CURRENTS, CORROSIVE SOILS, AND WALL LOSS

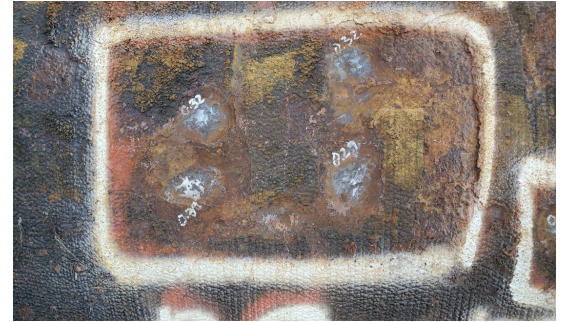
Validated pipe defect.

As the utility began preparing the pipeline for replacement, the main suffered a catastrophic failure at the precise location where the ultrasonic analysis determined the 72 percent wall loss.

Forensic analysis confirmed that stray currents and corrosive soils were contributing factors to the failure. Based on the results and newly acquired data, the utility intends to use additional decision intelligence solutions to monitor the main line and to identify other lines in their system with similar corrosive soil conditions. **The utility is now bolstered with powerful new insights (and reliable, innovative solutions like PipeDiver Ultra) to prioritize investment and reduce the incidence of dangerous, expensive, and unplanned water outage events.**

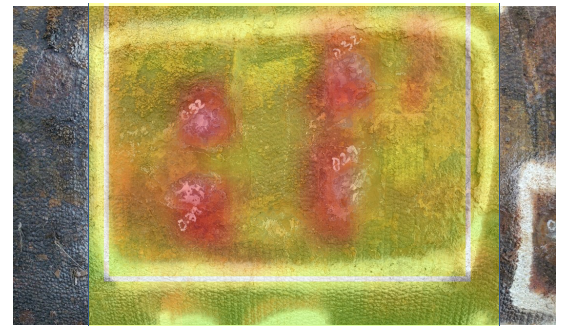
Validated defect with thickness map overlaid.

The inspection took place over two weeks in June 2018, starting with the free-flowing SmartBall technology, recommended for its acoustic sensitivity to small leaks and its ability to inspect long distances in one deployment. While the SmartBall inspection identified no leaks, the PipeDiver Ultra identified nine pipes with wall loss, with one area indicating a significant wall loss of 72 percent. The inspection also identified disruptive signals along the line, leading to the suspected presence of stray electrical currents related to the close proximity to a power plant, a potential factor affecting pipe corrosion. Xylem assembled a team of specialists to examine the line with **Spectrum XLI™**, an above-ground inspection technology, used to investigate and pinpoint interference locations. High levels of alternating current (AC) discharge were identified and pinpointed at two locations.

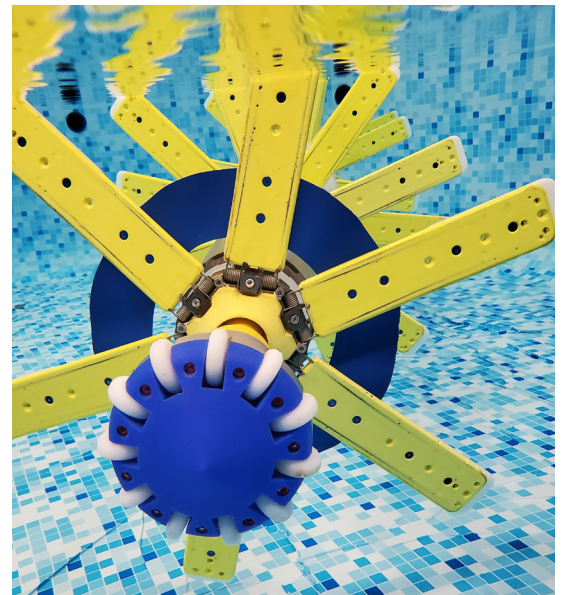
Xylem's PipeDiver Ultra pipeline condition assessment tool.

Since 2013, this large utility has partnered with Xylem to apply its Decision Intelligence approach to address its most critical water challenges. When the utility identified the main for priority inspection, they welcomed the strategy of combining a **SmartBall®** leak detection inspection with a pilot run of Xylem's cutting-edge **PipeDiver Ultra®**, an advanced condition assessment platform that analyzes ultrasonic data to deliver actionable insights on the physical integrity of the pipeline. The tool is **the industry's first high-resolution, free-swimming ultrasonic condition assessment tool for identifying and characterizing the depth of wall loss on metallic pipes.**
