Pipeline Inspection of Critical 20-year-old Mine Discharge Water Pipelines in Environmentally Sensitive Area

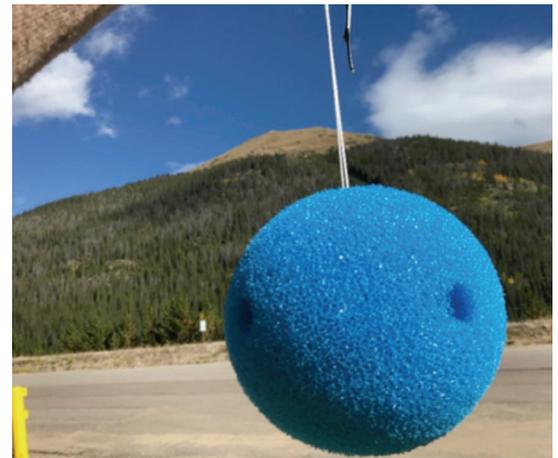
Xylem's innovative SmartBall solution - a free-swimming inline leak, gas pocket and mapping inspection platform - is readied for deployment.

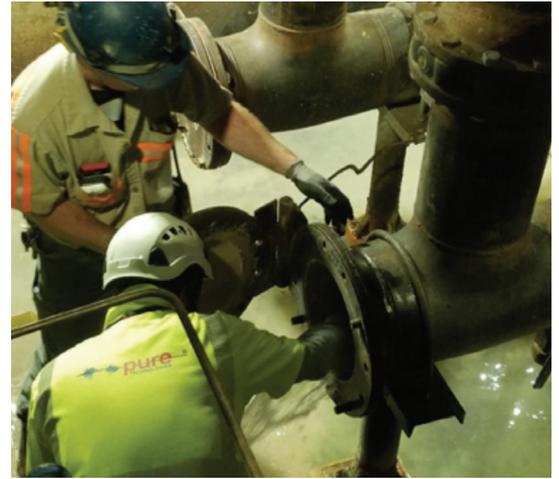
SmartBall is inserted into the pipelines through existing pipeline features. A two-day pipeline inspection revealed a medium-size leak in one pipe in the vicinity of a nearby creek.

A two-day inspection using the SmartBall Platform revealed a medium-size leak in one pipe in the vicinity of a nearby creek which could then be addressed through a targeted repairs program. The client was so impressed with the technology that they accelerated their timeline for further routine pipe inspections. The client commented on the team's preparedness, timely performance and ability to follow strict onsite safety requirements.

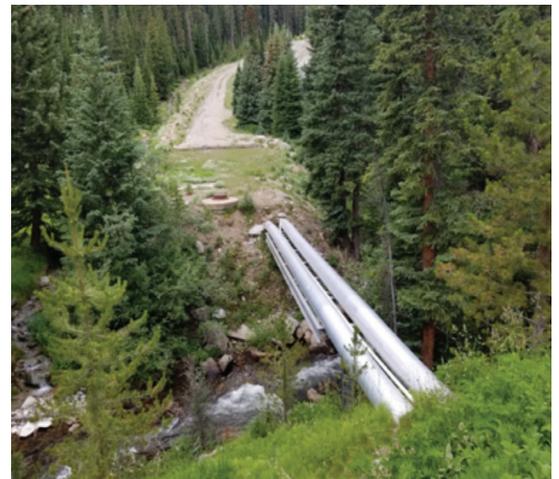
Mine discharge water pipelines crossing a creek in an environmentally sensitive area.

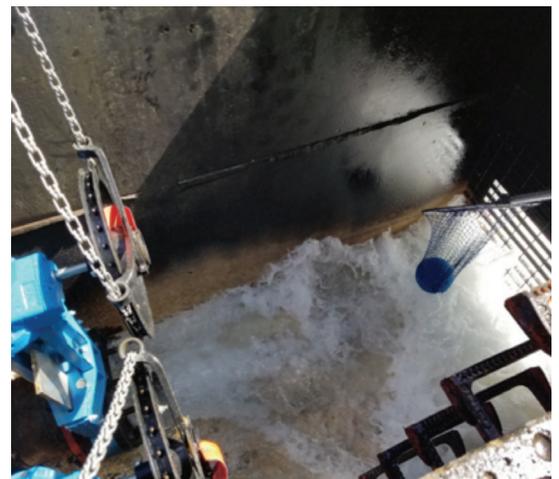
Retrieval of SmartBall tool at the pipeline discharge.
